Preservation Issues in the Patrick Tavern Porch Project

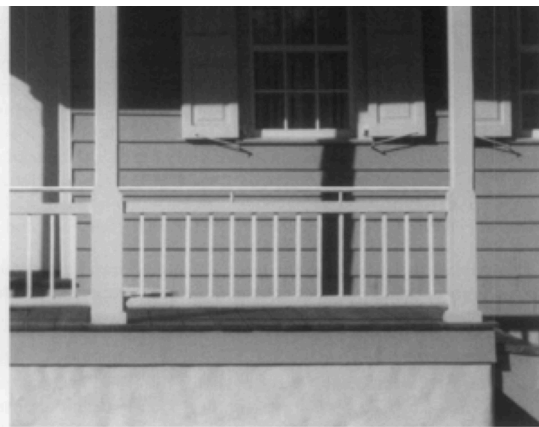
Figure 19. Historic porches generally have railings that measure 28 to 30 inches in height from the floor. When additional height is necessary for safety, a simple rail, added for illustration purposes in this photograph, can usually be installed above the historic railing. Not only does this treatment allow retention of the historic balustrade, but it also has a minimum impact to the appearance of the porch. Photo: Charles Fisher.

Railing: The low porch railing does not conform to modern safety standards. Preservation Brief #45, an interpretive guide for the Sec. Interior’s Standards, suggests a simple additional rail above the railing to give the required height.

Historic porches generally have handrails that measure 28 to 30 inches in height from the floor. Current code requirements for new construction generally mandate that railings be 36 to 42 inches in height (often 36 inches for single family dwellings, and 42 inches for multi-family dwellings and commercial buildings). Raising the historic railing by as much as 30% or more can have a major impact on not just the proportions of the balusters, but also on the overall appearance of a historic porch. Adding a simple rail above the historic railing and painting it to hide its presence as much as possible is generally the least intrusive solution when this safety requirement must be met. Similarly, an existing bottom rail is sometimes set too high off the deck to meet contemporary code requirements. The addition of a simple wood rail or even a narrow metal pipe below the bottom rail will usually suffice (Fig 19).

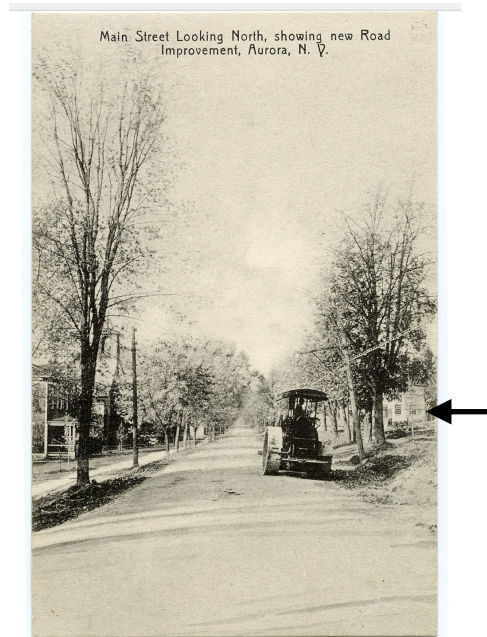
Windows: Early windows would have had small panes; the current new windows (6 over 6 and 9 over 9) replicate that. At some point before the 1935 photo, the windows were redone as 2 over 2). SHPO proposed that the 1875 windows were 2 over 2; however, there is no info on whether older windows were retained or new ones added then. This postcard, ca. 1900, shows the back end of the building, with 4 over 4 windows. This suggests that owners might have kept the older, small-paned windows throughout.

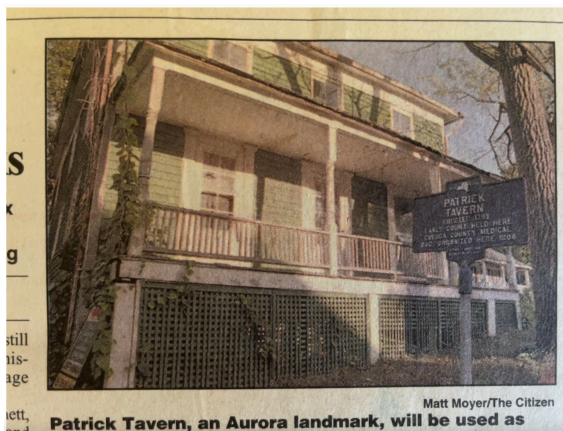
Lattice: Upon request, I found later (1992? and 1997) close-ups of the lattice under the porch. Unlike many of today's products, it had very small square openings. The contractor believes this product is still available.
